Manhole Inspection Summary

Manhole # S35MM1023MH

Insp Date: **3/12/07 4:26 PM**

Location Address: **309 OLD COLD SPRING LA**

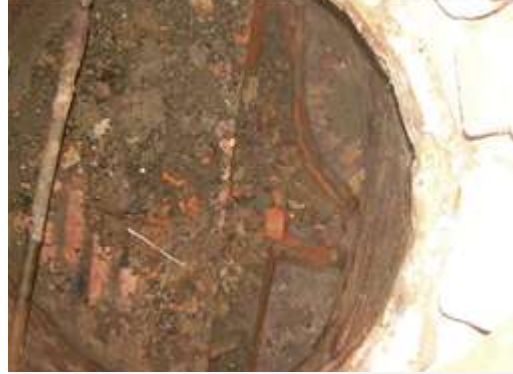
Top View

Bench and Channel debris.

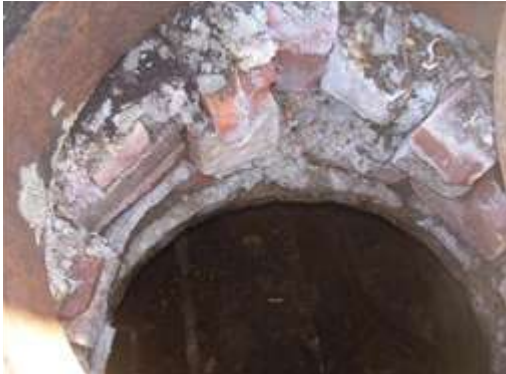
Defect

Frame leaks. Frame offset. Adjustment deterioration, loose brick and infiltration. Corbel and Barrel infiltration.

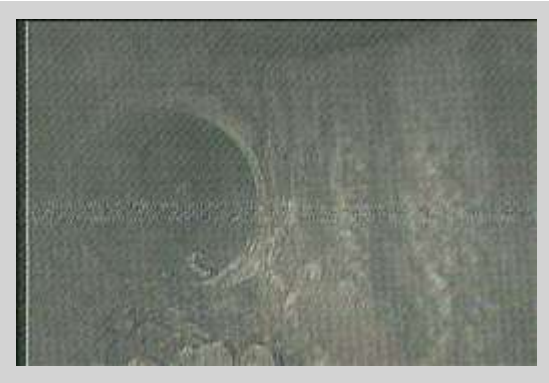
8 in. Circular Gravity Sewer Pipe Out @ 12 O'Clock

Connects To: **Stub connection / abandoned**

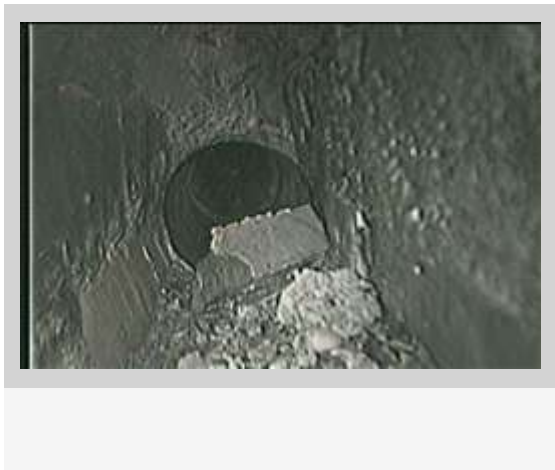
6 in. Circular Gravity Sewer
Pipe In @ 6 O'Clock

Deposits: ☐ None ☐ Mud ☐ Sludge ☒ **Debris** ☐ Grease

Silt Depth: **0** (in.) Deposits Extent: **Medium**

Infiltration: **Evidence** Pipe Seal Cond: **Unknown**
